**DEPARTMENT OF TRANSPORTATION**

Contract #: 04-0120F4Cty: SF/ALA Rte: 80 PM: 13.2/13.9File #: 69.28**WELDING INSPECTION REPORT****Resident Engineer:**Siegenthaler, Peter**Address:** 333 Burma Road**City:** Oakland, CA 94607**Report No:** WIR-017790**Date Inspected:** 26-Oct-2010**Project Name:** SAS Superstructure**OSM Arrival Time:** 1900**Prime Contractor:** American Bridge/Fluor Enterprises, a JV**OSM Departure Time:** 700**Contractor:** Zhenhua Port Machinery Company, Ltd (ZPMC), Changxing Island **Location:** Shanghai, China**CWI Name:** See Below**CWI Present:** Yes No**Inspected CWI report:** Yes No N/A**Rod Oven in Use:** Yes No N/A**Electrode to specification:** Yes No N/A**Weld Procedures Followed:** Yes No N/A**Qualified Welders:** Yes No N/A**Verified Joint Fit-up:** Yes No N/A**Approved Drawings:** Yes No N/A**Approved WPS:** Yes No N/A**Delayed / Cancelled:** Yes No N/A**Bridge No:** 34-0006**Component:** OBG**Summary of Items Observed:**

## WELDING INSPECTION REPORT

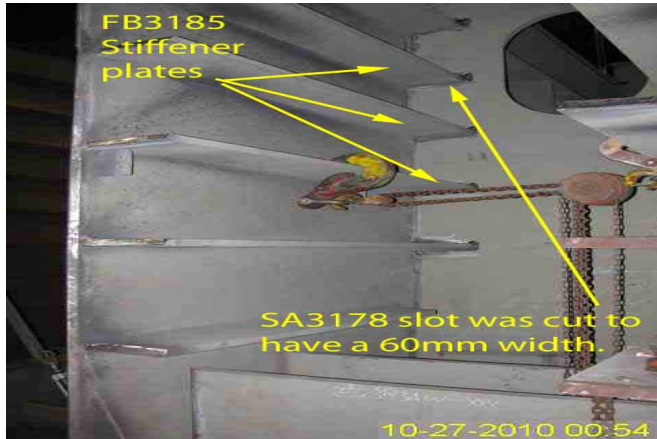
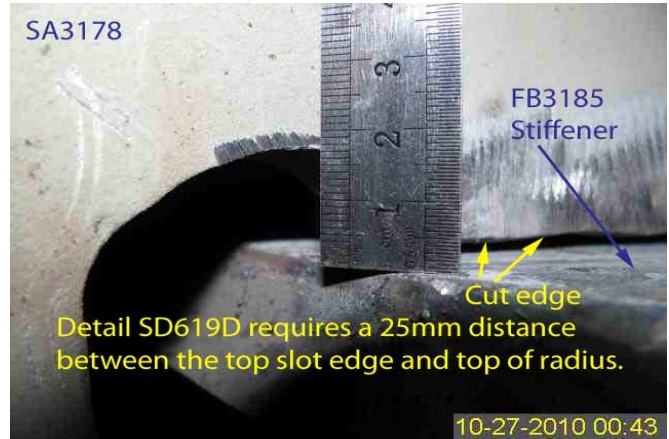
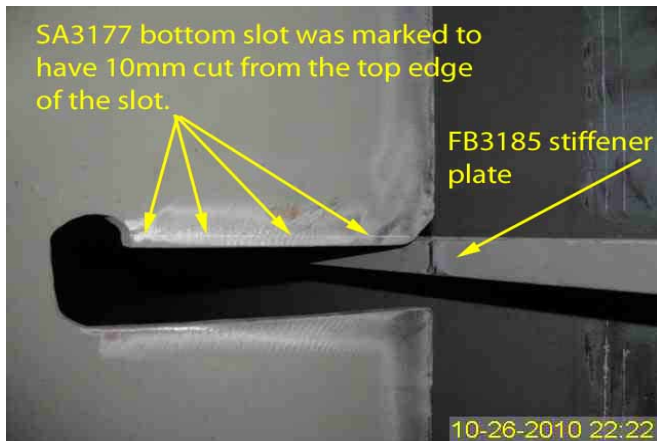
This QA Inspector observed ZPMC used an acetylene torch to cut approximately 10 mm of material from the top of two slots in longitudinal diaphragm sub assemblies SA1377 and SA3178 and several of the other slots were cut

between 2 and 6 mm. ZPMC cut these slots to allow floor beam FB3185-001 in place. Approved shop drawings SA3177 and SA3178 specifies a 60mm wide slot as detailed on drawing SD619C and SD619D and the actual maximum observed width was 70mm in two of the slots. Drawings SA3177 and SA3178 both specify the top of the radius is to extend 25mm above the top of the slot and actual minimum height was 15mm in two of the slots. Drawings SA3177 and SA3178 specify the chamfer of the upper front slot edge to be 25mm and the minimum required cope distance is approximately 15mm in two of the slots. This QA Inspector informed ZPMC CWI Mr. Zhang Zhong that an incident report will be issued to document the out of tolerance slots. See the photographs below for additional information.
